This guidance document is prepared for use by Fort Bend County staff, Developers, Engineers, and Contractors to provide understanding and clarity of County pavement requirements for acceptance of public roadways into County Maintenance. The General Acceptance Procedures can be found in the Fort Bend County Regulations of Subdivisions, Section 6 – Acceptance of Improvements within Subdivisions. This document provides guidance on when local, residential pavement can be repaired and when it will be replaced.

The following elements are covered in this document:

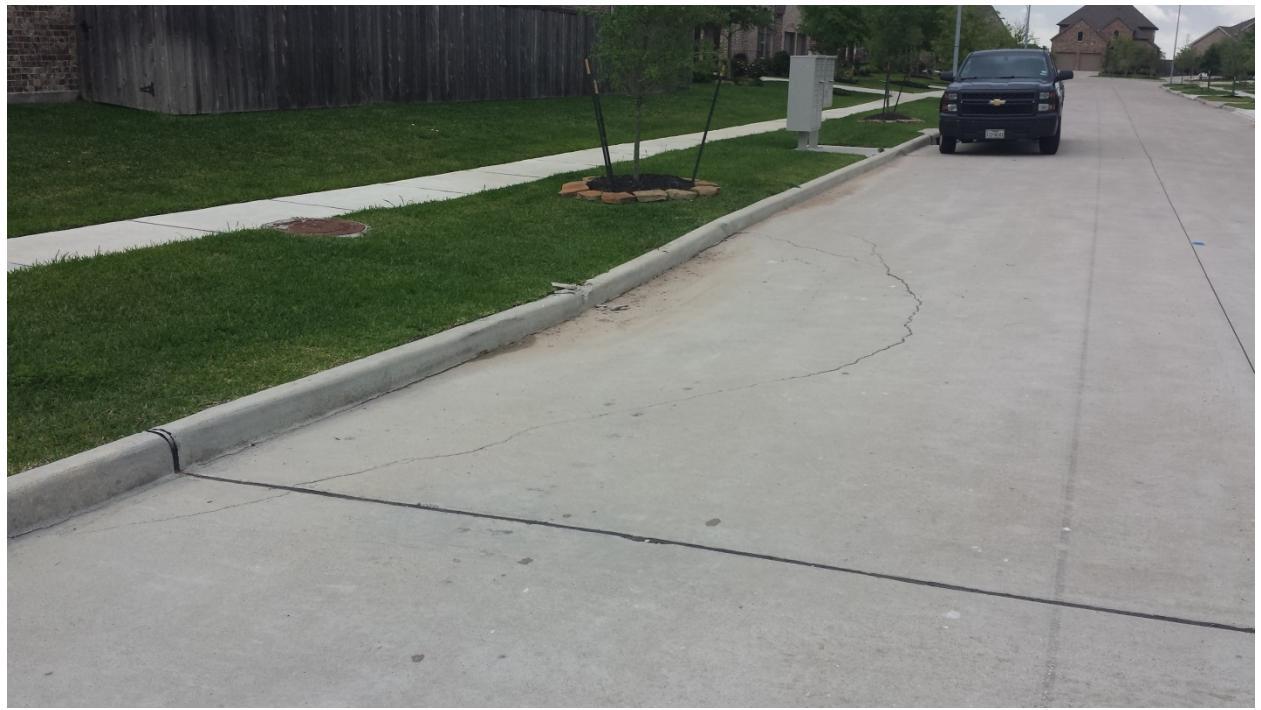
Half-moon cracking is caused by inadequate backfill compaction around manholes. Address utility backfill issue and then remove and replace pavement.

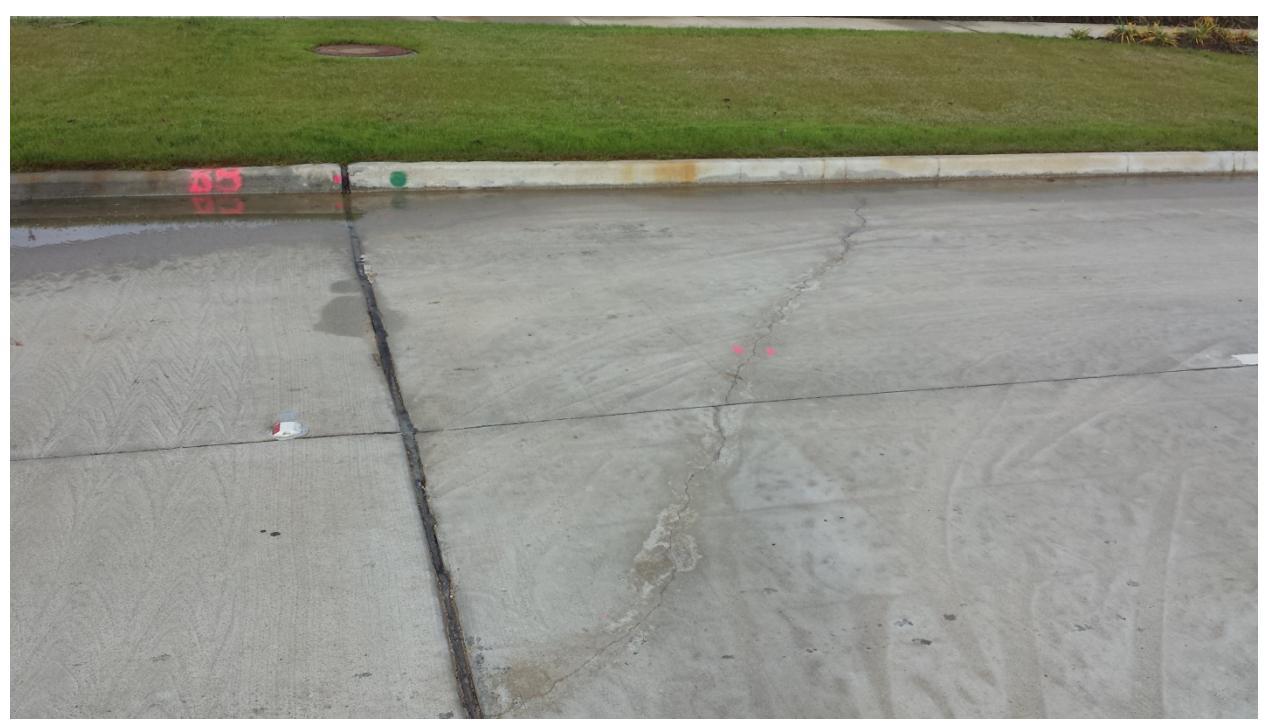
When corner cracking within 10 feet of expansion joint occurs, remove and replace pavement.

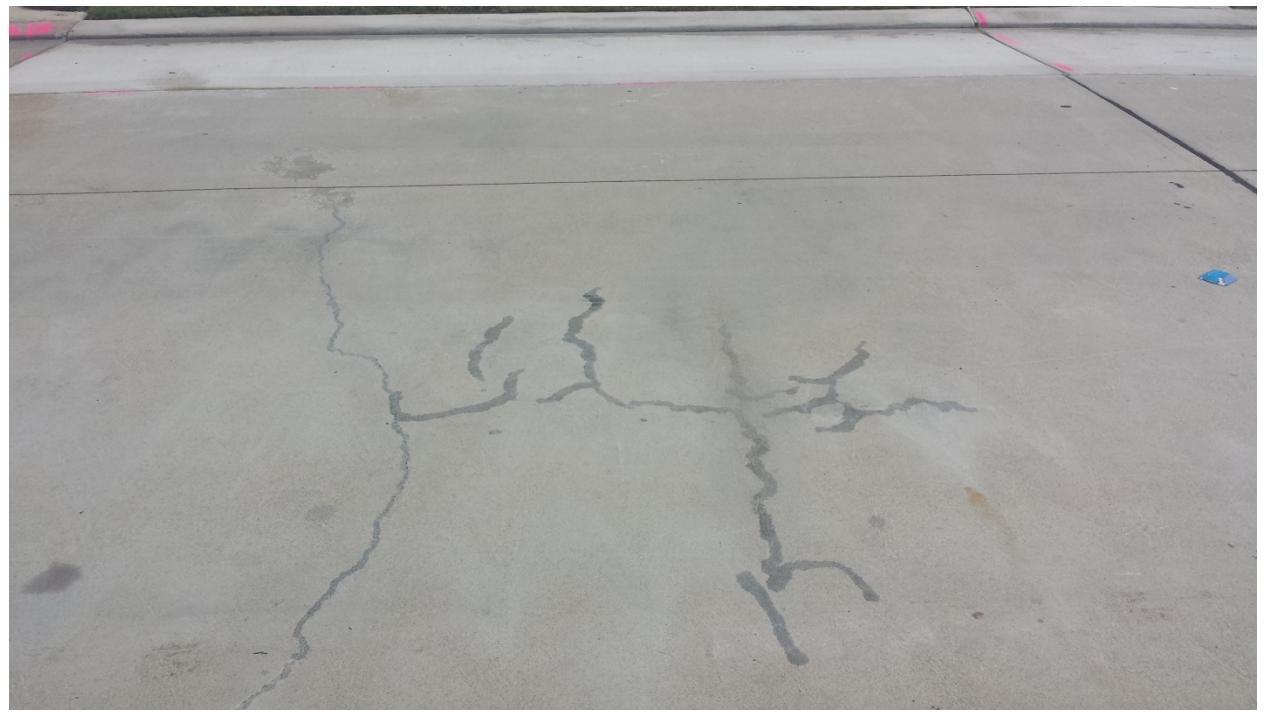
Multiple cracks may be sealed using an approved injected epoxy sealant at the beginning of the one year maintenance period. Panels will be re-evaluated at the end of the maintenance period to determine the effectiveness of this treatment. If minor additional pavement movement has reopened or lengthened cracks, resealing will be required. If there is significant additional cracking or vertical movement is observed, pavement replacement will be required. **All sealants must be applied in strict compliance with manufacturer's recommendations.**

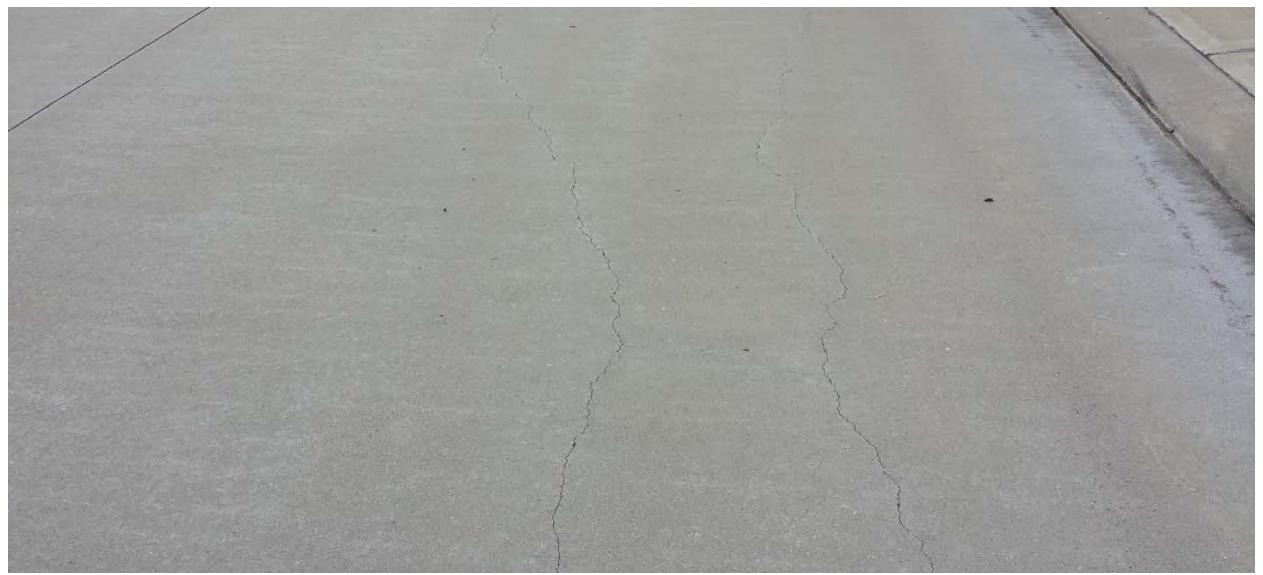
Longitudinal cracks can be sealed under some conditions as long as there is not an associated bird bath. Excessive width, vertical movement at the crack, or associated bird bath will require pavement replacement.

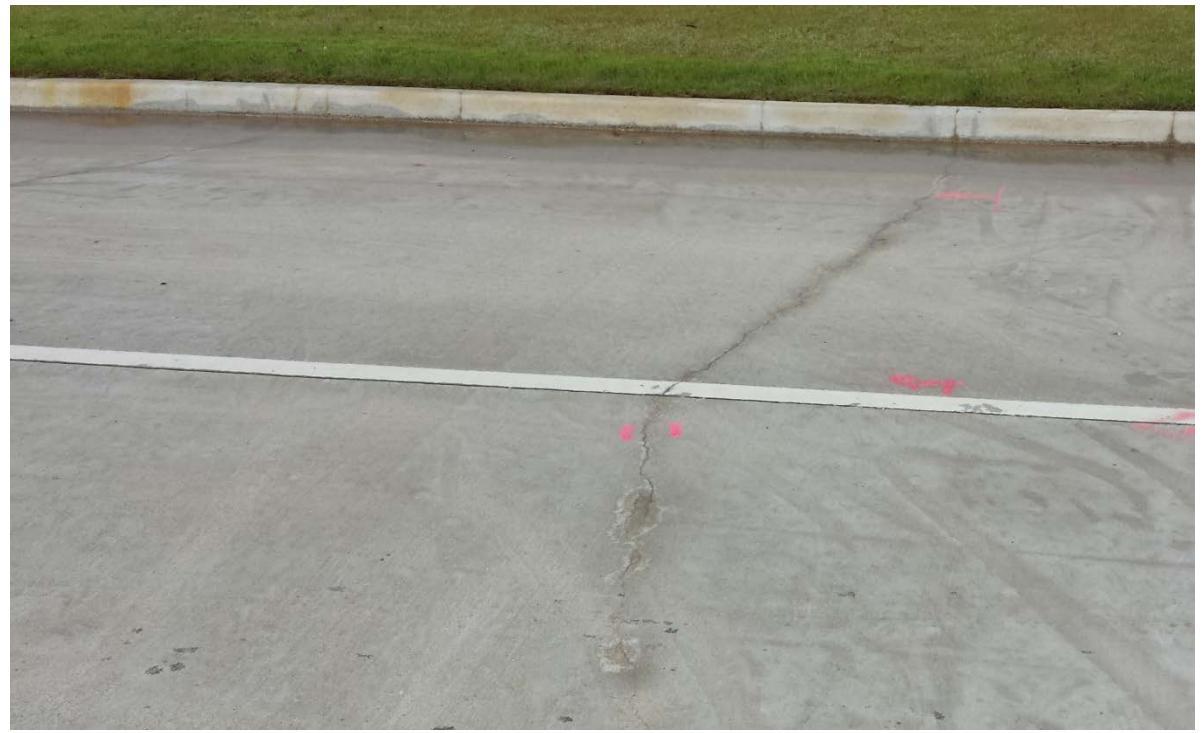
Lateral cracks can be sealed under most conditions. Excessive width, raveling, or vertical movement at the crack will require pavement replacement.

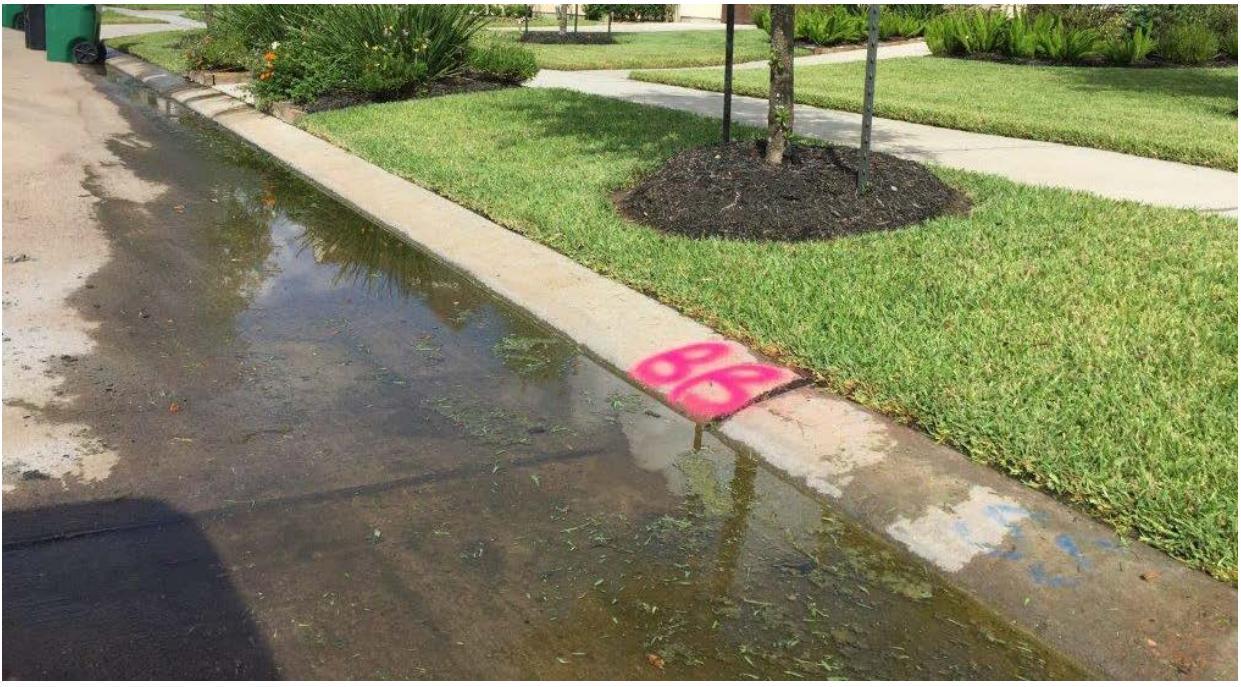
Bird bath extends into driving lane; pavement replacement is required.

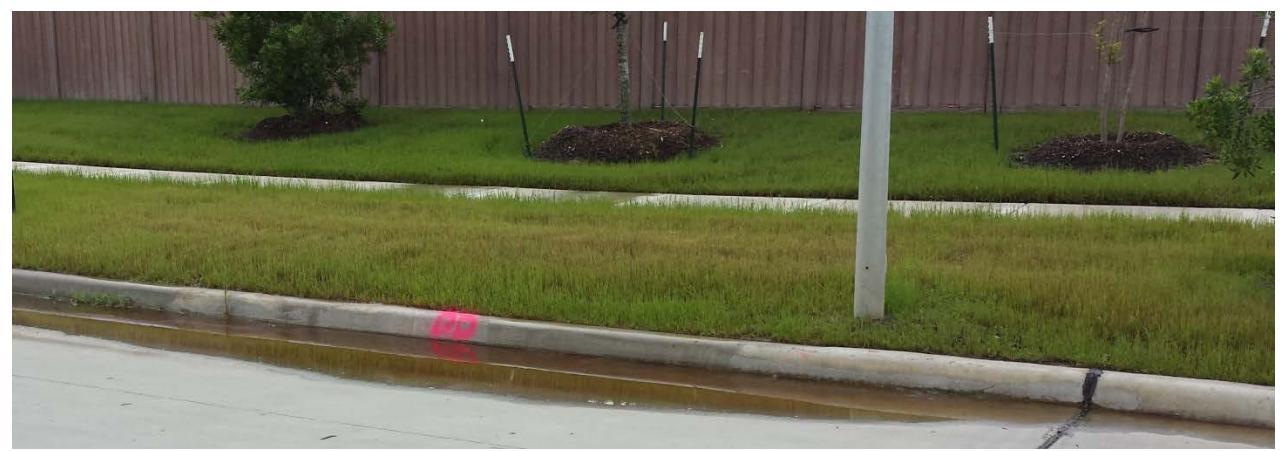
Bird bath has significant length and depth. Lifting, light grinding, or removal of joint sealant obstruction may be acceptable based on field conditions.

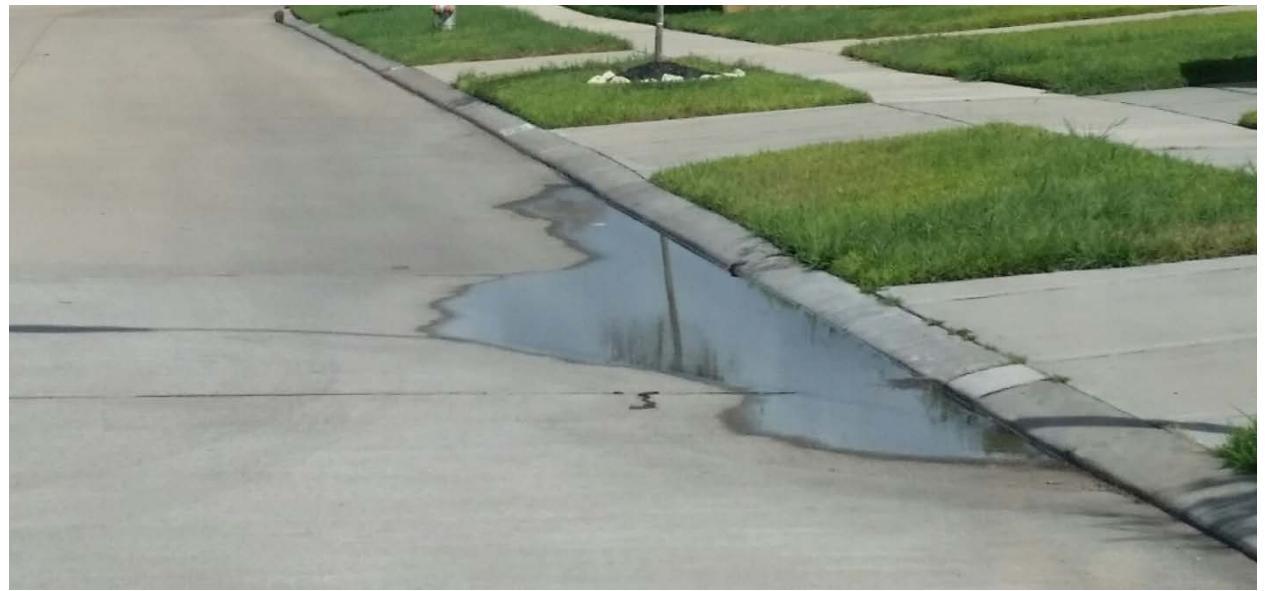
Bird bath has significant length, width, and depth. Lifting or pavement replacement is required.

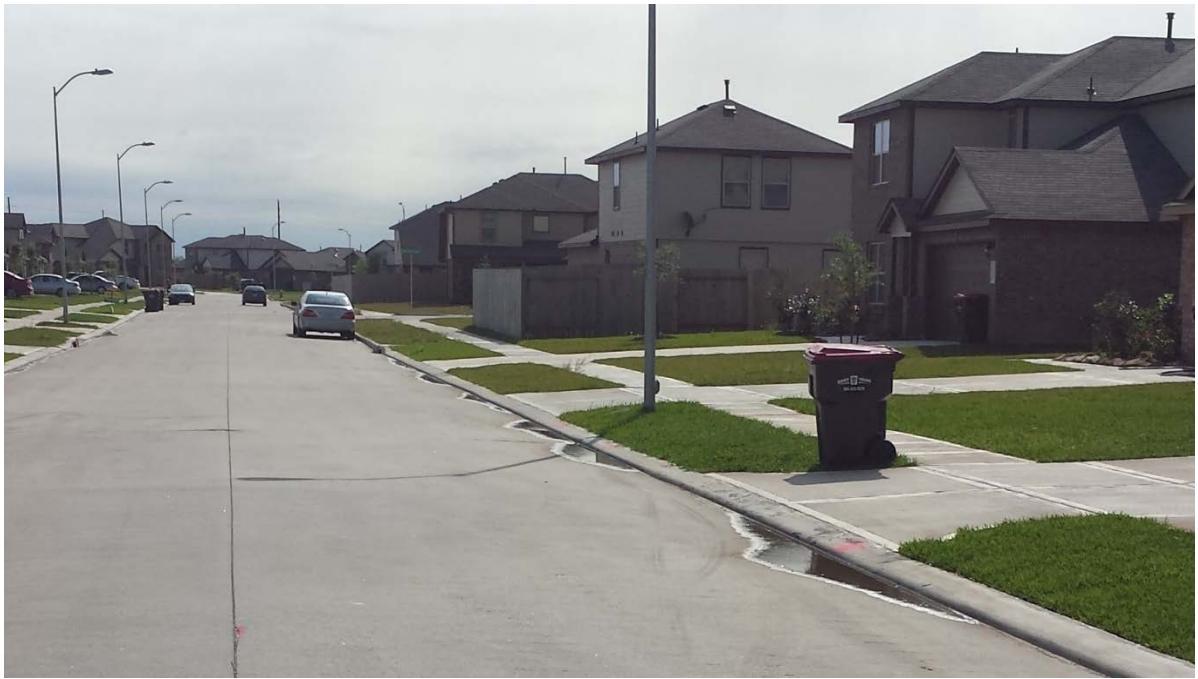
Bird baths which are relatively small in length, width, and depth do not require pavement replacement or lifting. Allowable width is approximately 12 inches. Allowable depth is approximately ¼ inch.

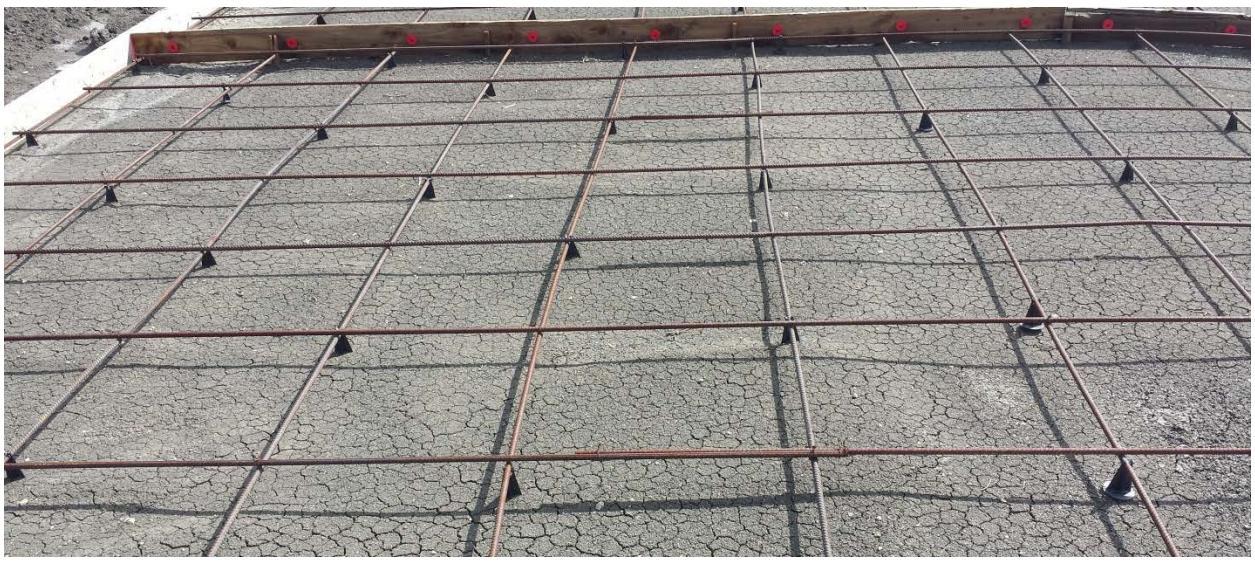
Subgrade is too dry.

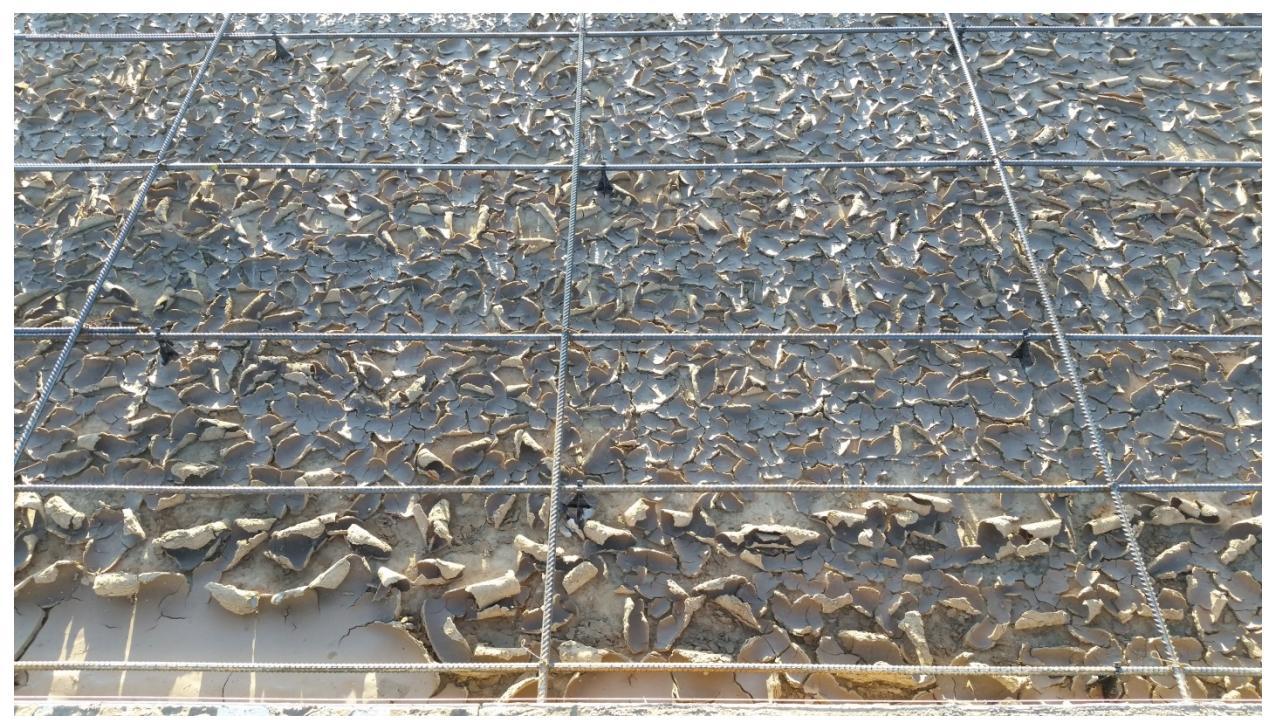
Subgrade is too dry.

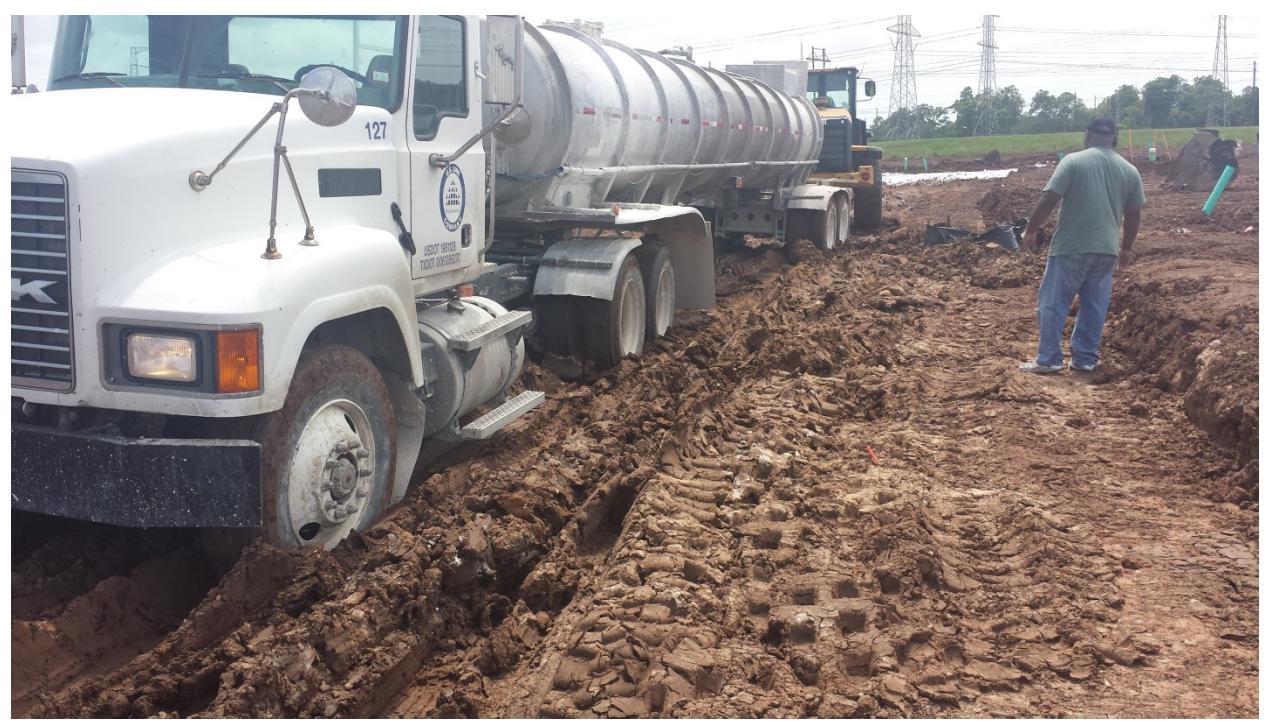
Possible deficiencies in subgrade and base include: Inadequate proof rolling or improper mixing of lime for subgrade, not extending lime mixture to edges of proposed limits of the stabilized subgrade, calculating lime for a 6 inch subgrade and mixing it 8 or more inches deep.

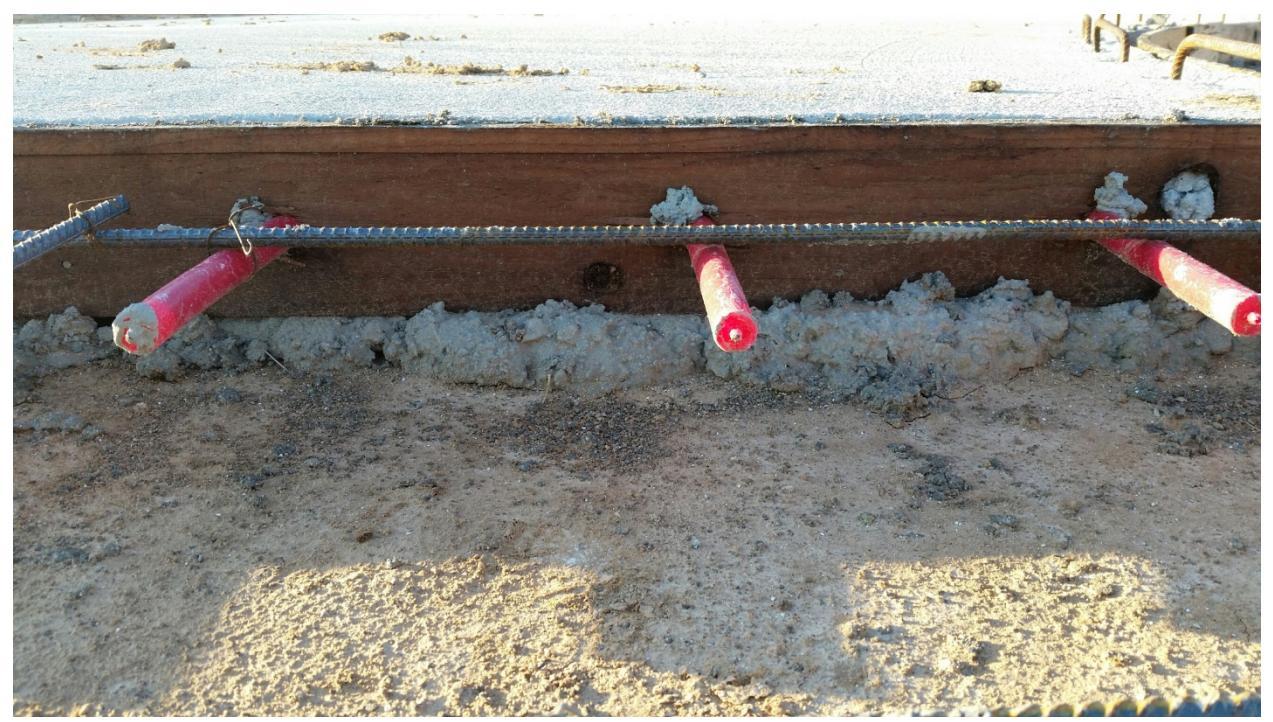
Concrete under headers at expansion joints does not allow expansion to occur correctly.

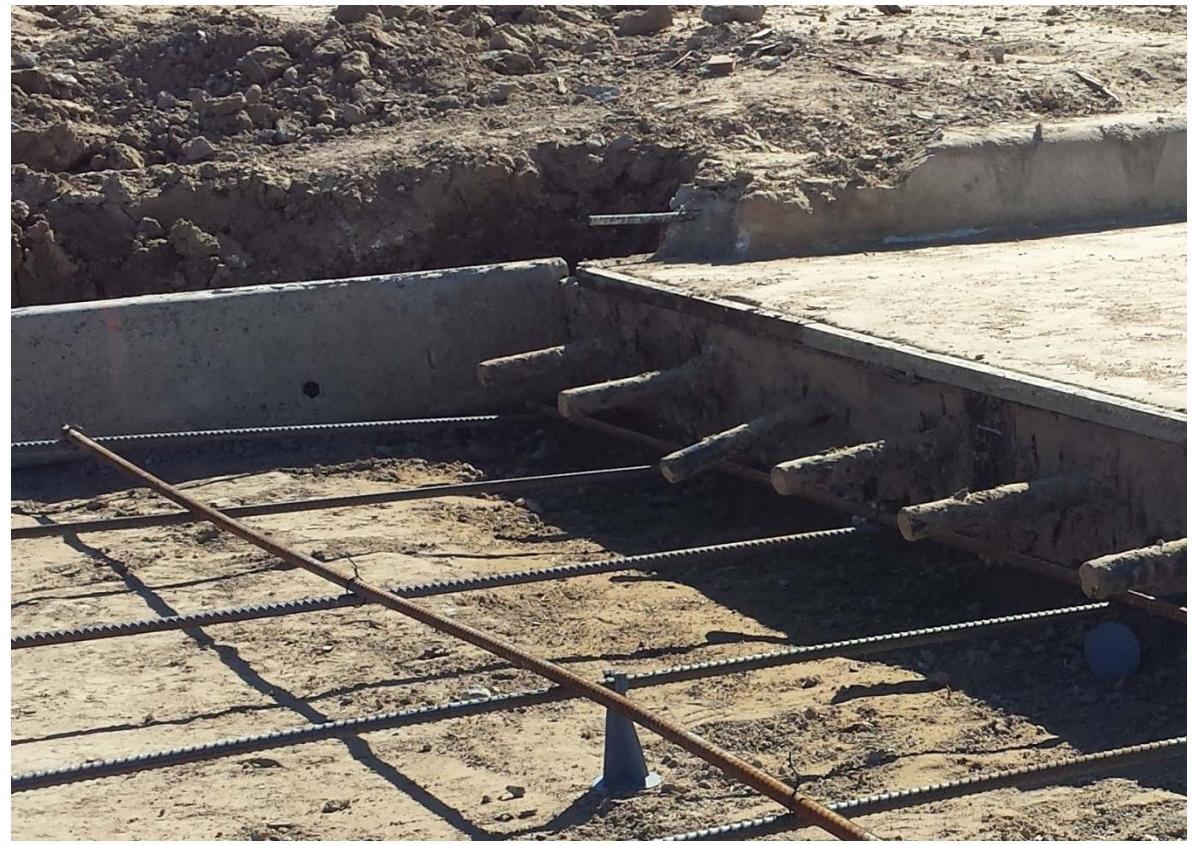
Misaligned dowels

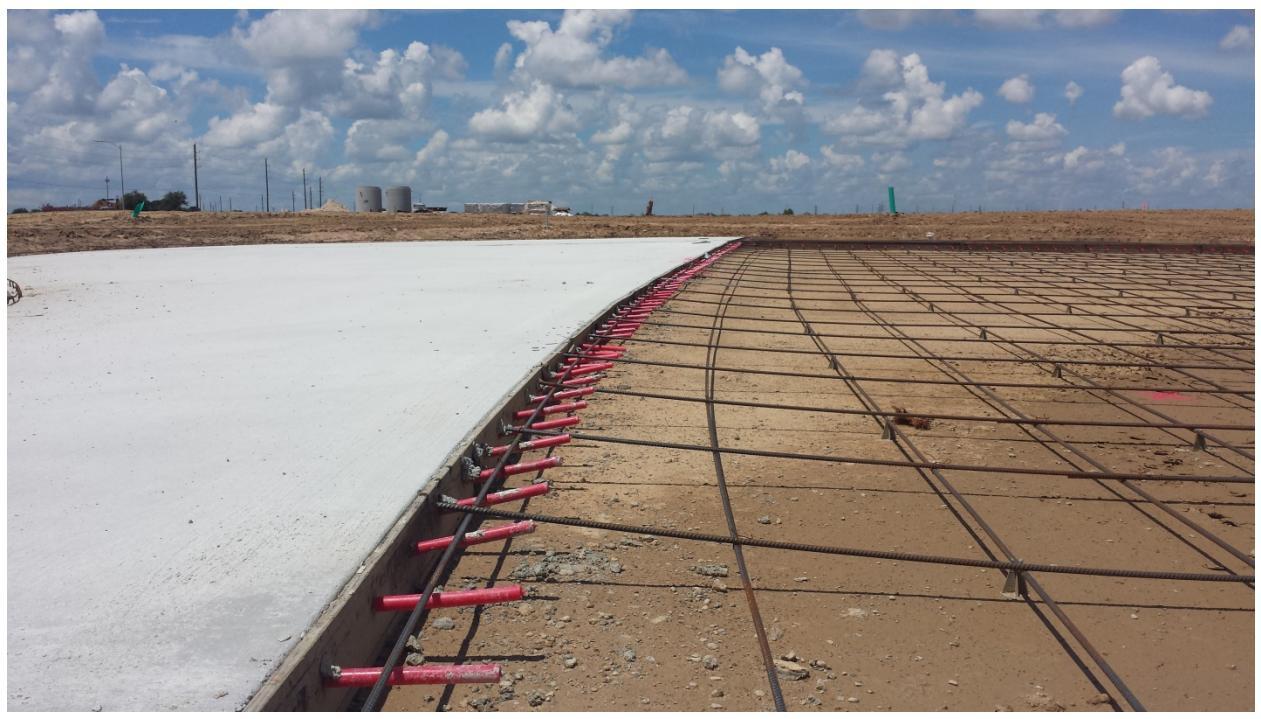
Misaligned dowels

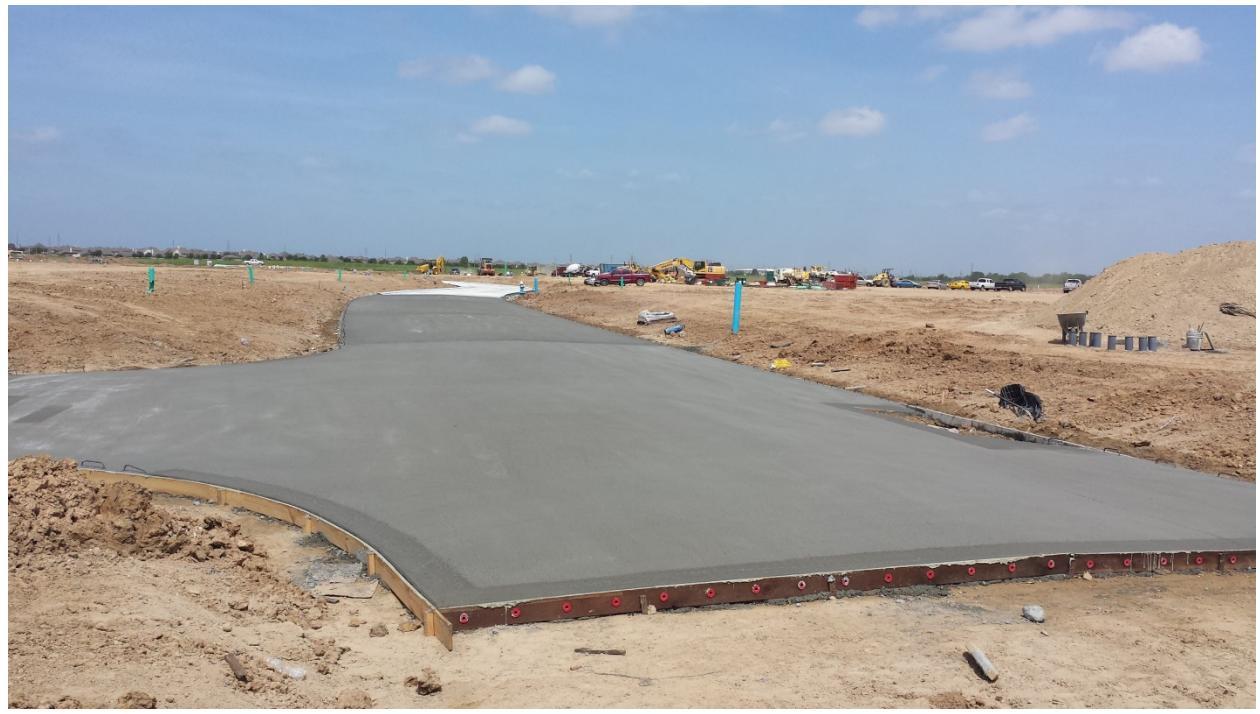
Membrane curing compound not applied to pavement

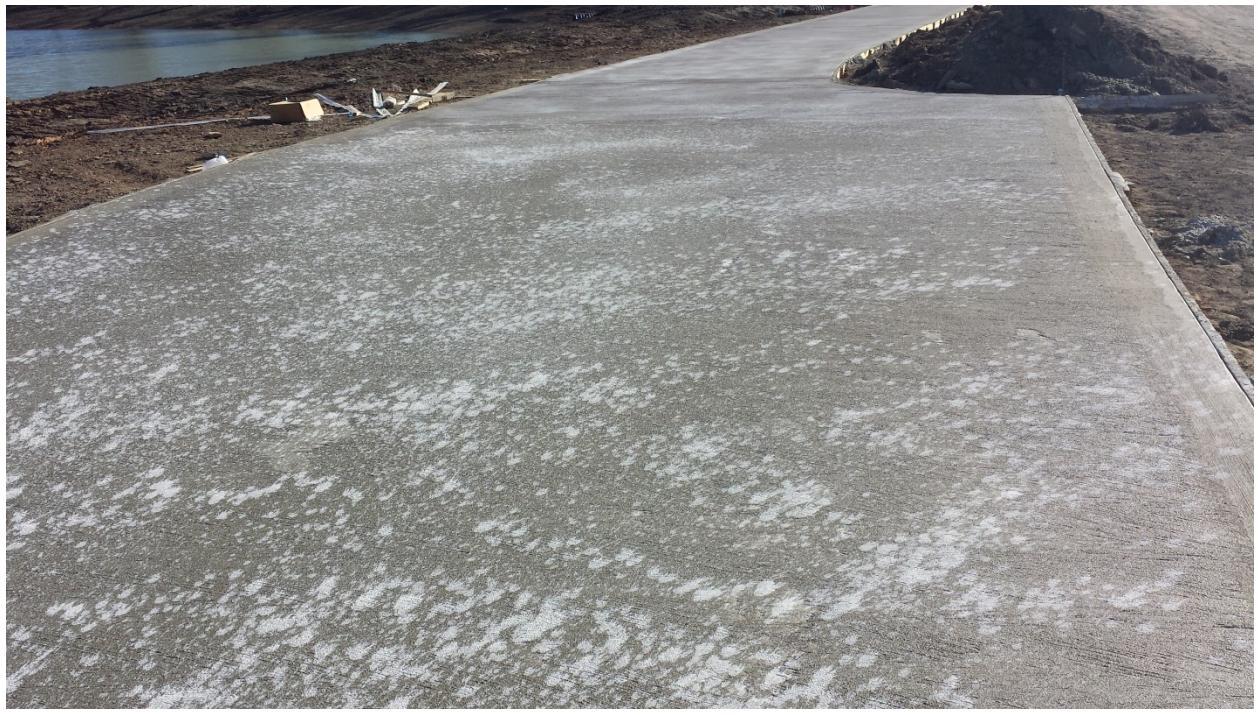
Inadequate curing compound

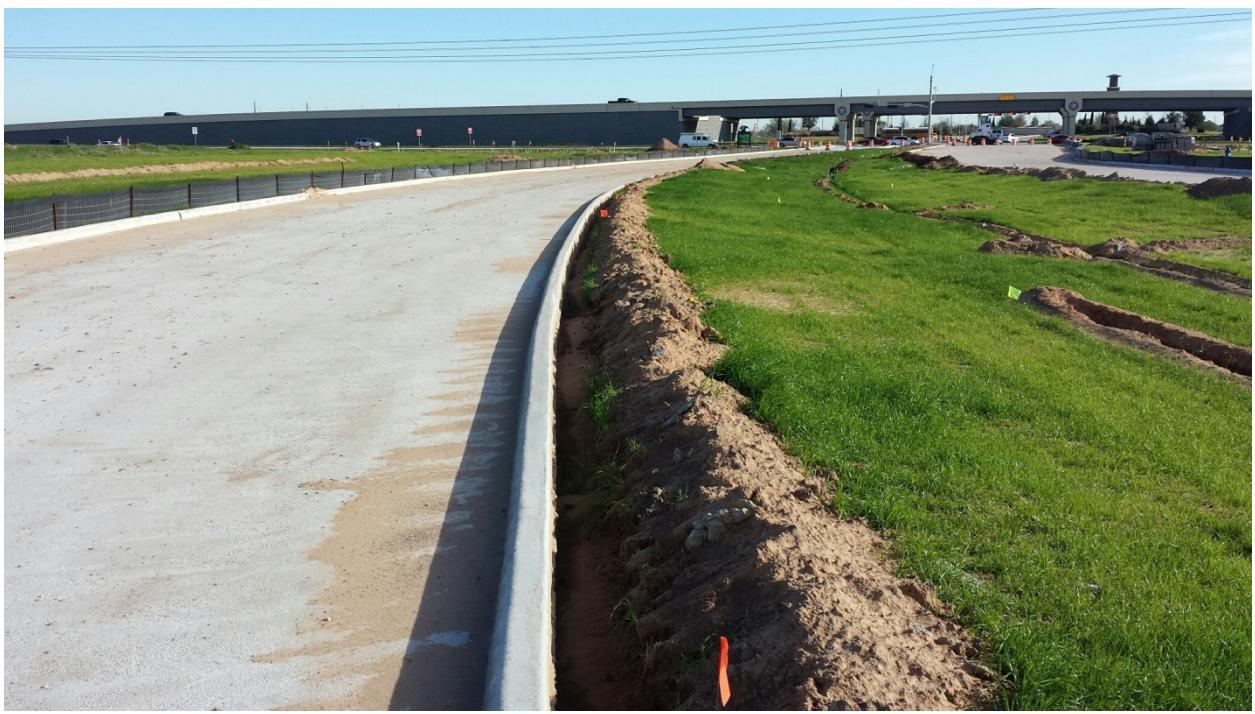
Silt fence or irrigation is placed directly behind curb cuts through subgrade and impacts lateral support.

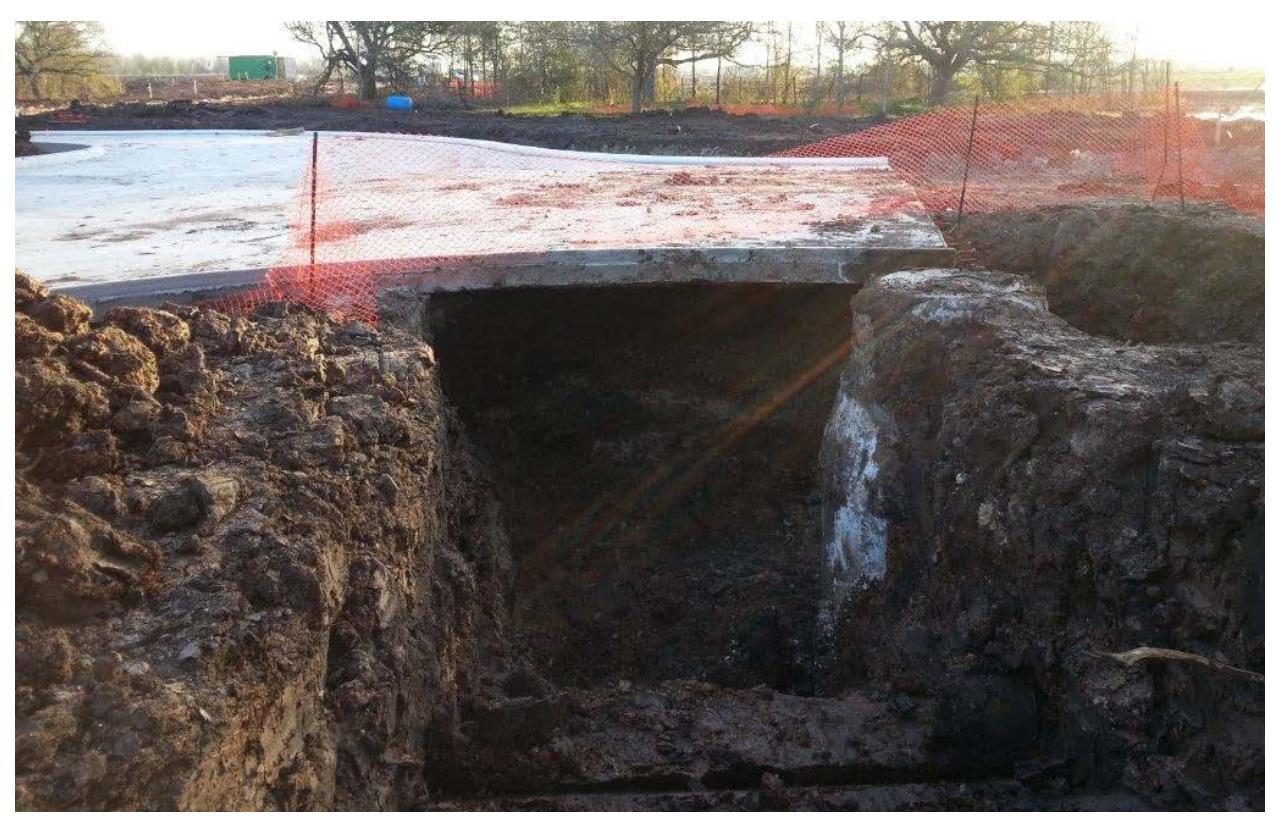
Excavation under or near pavement

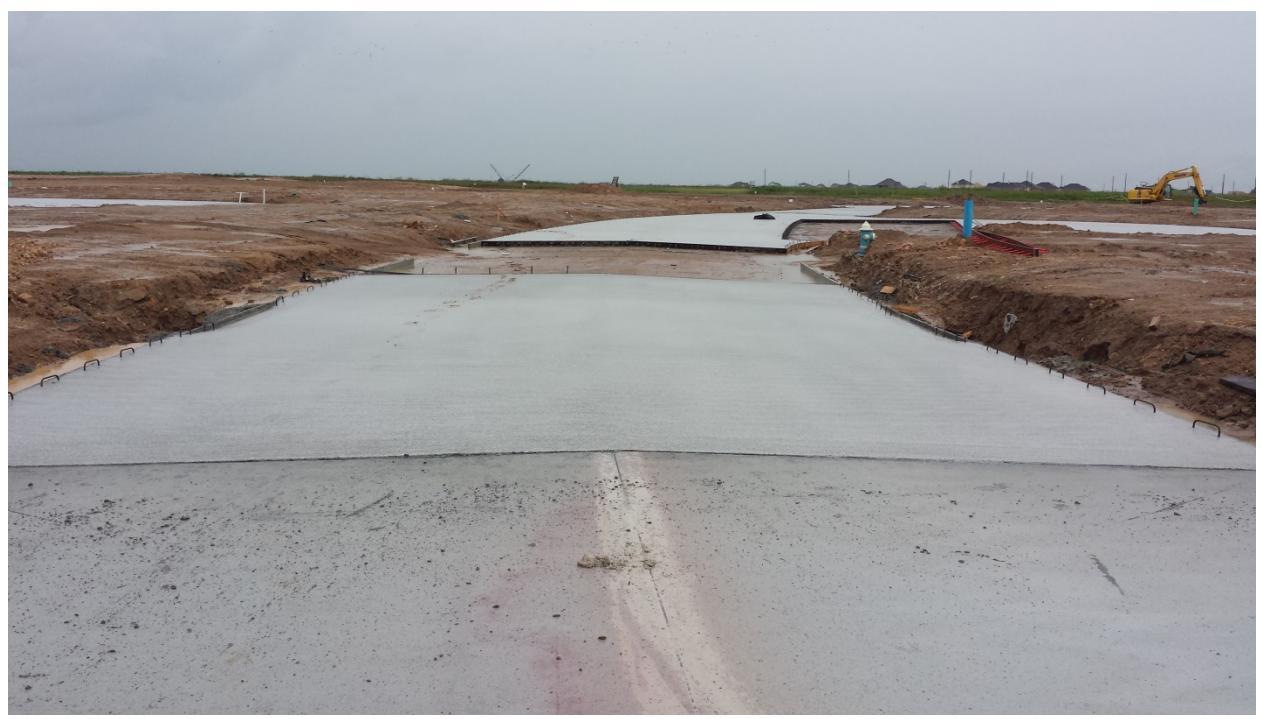
Not saw cutting within specified time (photo shows 4 day old concrete with no sawcuts)

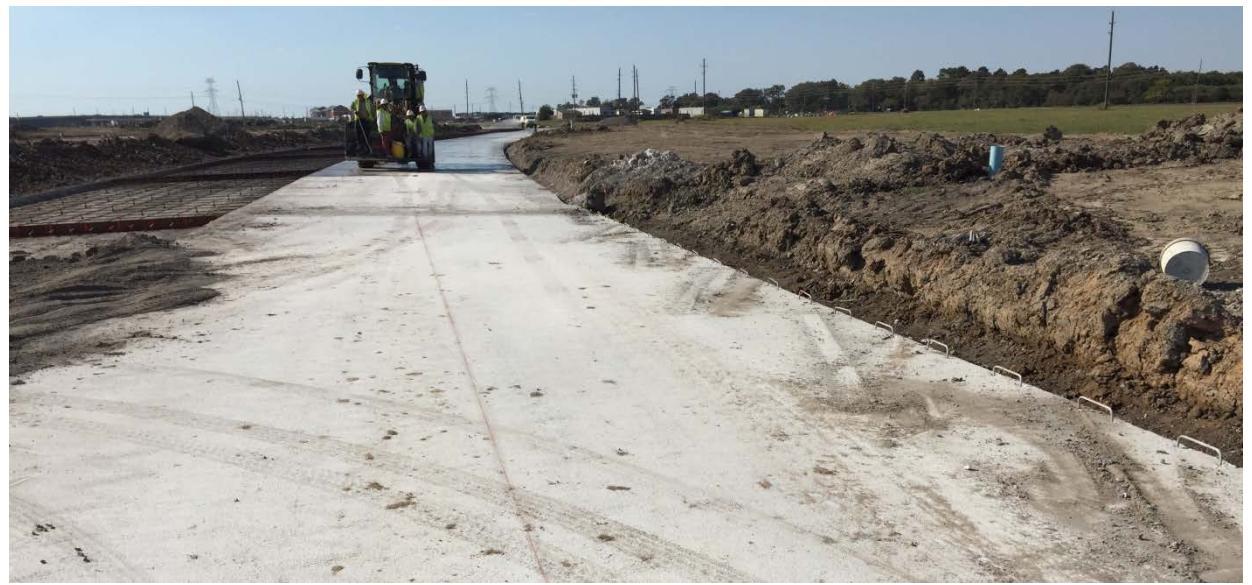
Equipment operating on pavement with inadequate cure time
