# Appendix X - Street Acceptance Guidelines

This guidance document is prepared for use by Fort Bend County (FBC) staff, Developers, Engineers, and Contractors to provide understanding and clarity of County pavement requirements for acceptance of public roadways into County Maintenance. The General Acceptance Procedures can be found in the FBC Regulations of Subdivisions, Section 6 – Acceptance of Improvements within Subdivisions. This document provides guidance in determining if concrete pavement can be repaired and when it is necessary to replace.

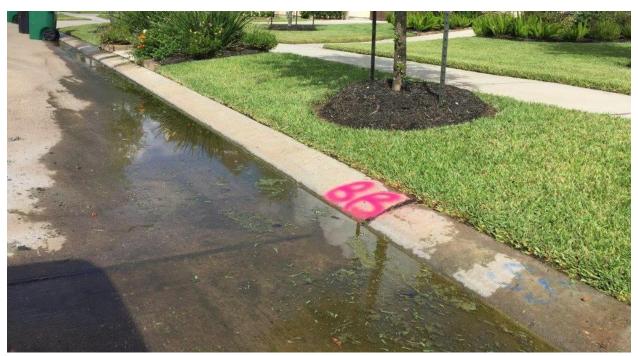
Image 1 - Bird bath extends into driving lane; corrective measures required.

The following images are of bird baths that would require correction. Correction may be pavement removal and replacement, light grinding, lifting, or removal of obstruction (i.e. joint sealant). The extent of pavement removal will be determined in the field with FBC Engineering staff based on location of bird bath, joints, cracks, inlets, or other items.

Light grinding may be done within 6 inches of the curb and no more than 1/2 inch in depth. Grind must be "feathered" so as not to create an edge.

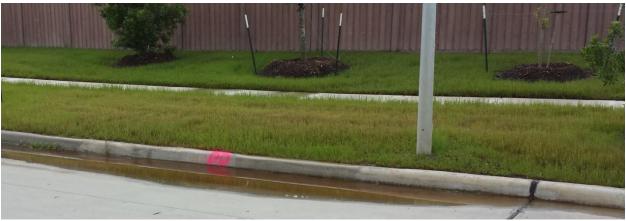
Image 2 - Bird bath has significant length and depth. Lifting, light grinding, or removal of joint sealant obstruction may be acceptable based on field conditions. Grinding shall be limited to 15' either side of the expansion joint.

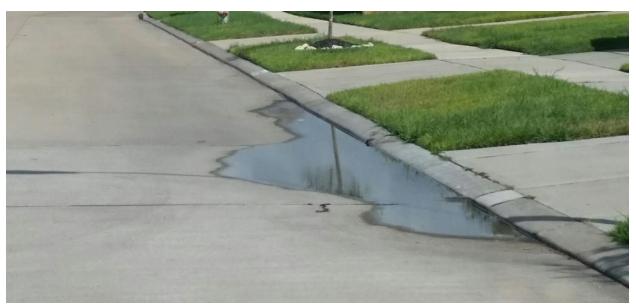
Image 3 - Bird bath has significant length, width, and depth. Lifting or pavement replacement is required. If the lifted pavement cracks then use Concrete Pavement Cracking Evaluation Criteria included in this document.

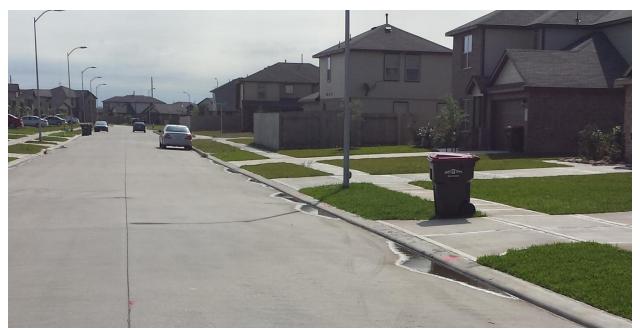
Image 4 - Bird baths which are relatively small in length, width, and depth do not require pavement replacement or lifting. Allowable width is approximately 12 inches.

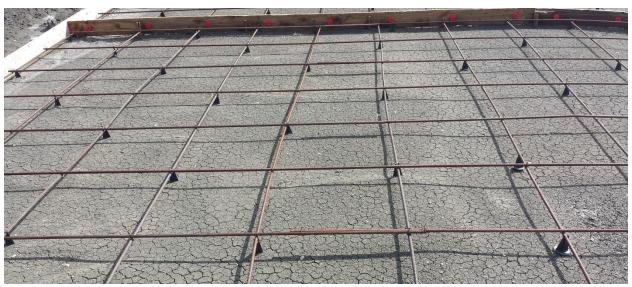
Image 5 - Subgrade is too dry.

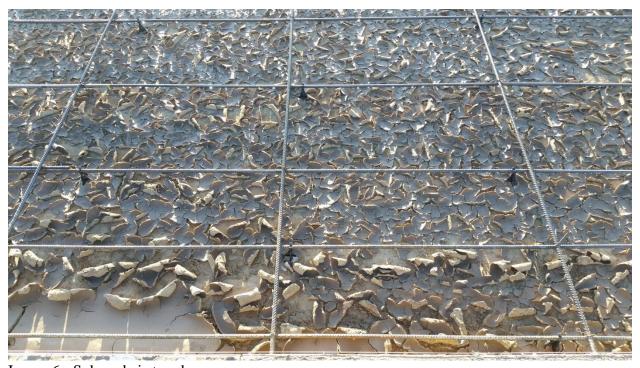
Image 6 - Subgrade is too dry.

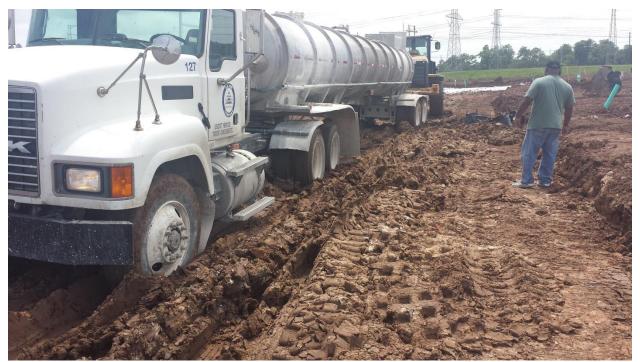
Image 7 - Possible deficiencies in subgrade and base include: Inadequate proof rolling or improper mixing of lime for subgrade, not extending lime mixture to edges of proposed limits of the stabilized subgrade, calculating lime for a 6 inch subgrade and mixing it 8 or more inches deep.

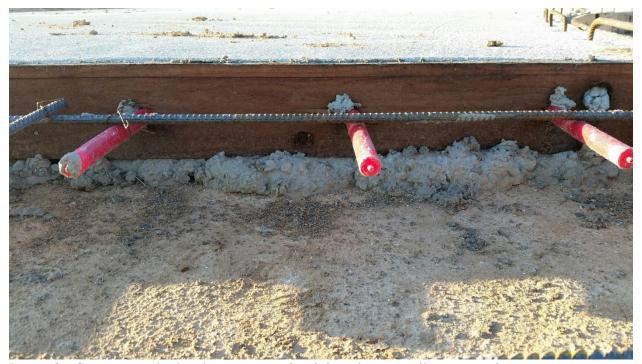
Image 8 - Concrete under headers at expansion joints does not allow expansion to occur correctly.

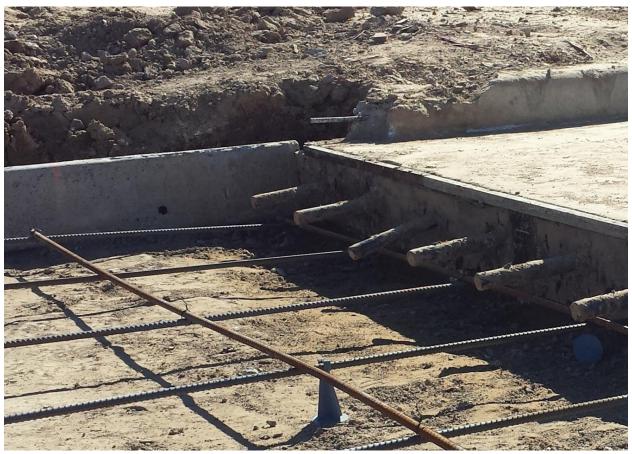
Image 9 - Misaligned dowels may cause spalling near the joint.

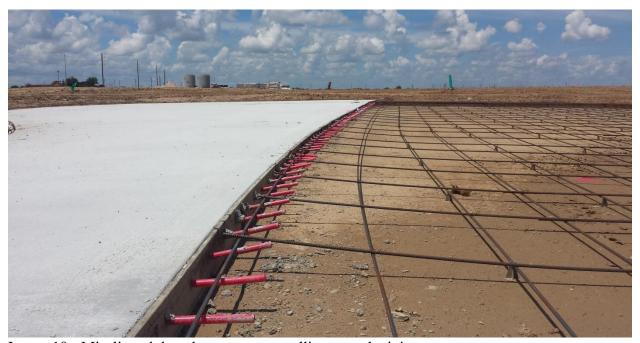
Image 10 - Misaligned dowels may cause spalling near the joint.

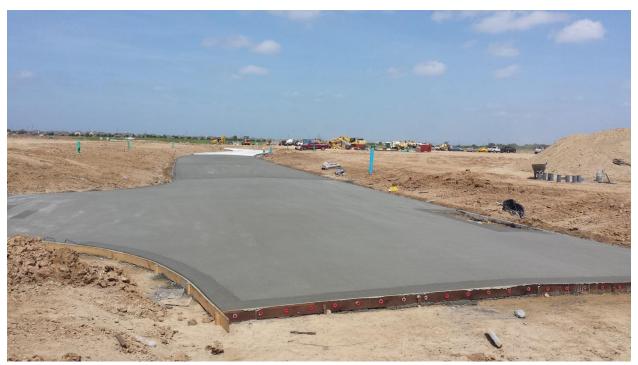
Image 11 - Membrane curing compound not applied to pavement

Membrane curing compound shall be applied as soon as the surface water disappears in compliance with the manufacturer's recommendations. Sawing shall take place when concrete strength is acceptable for sawing and in compliance with the specifications without creating excessive raveling along the sawcut.

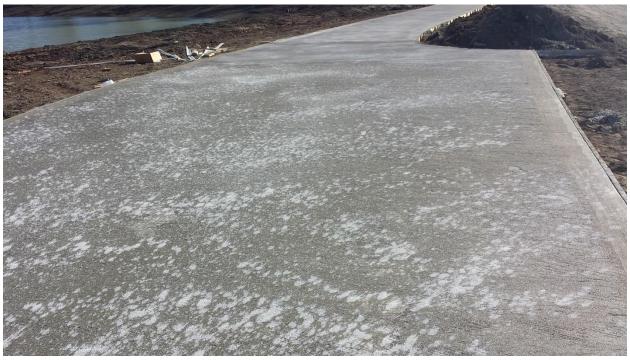
Image 12 - Inadequate curing compound

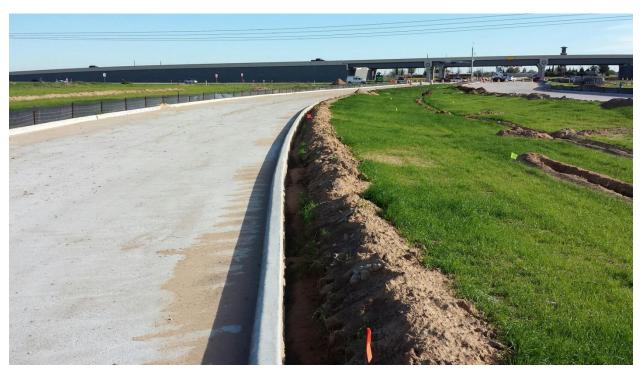
Image 13 - Silt fence or irrigation is placed directly behind curb cuts through subgrade and impacts lateral support.

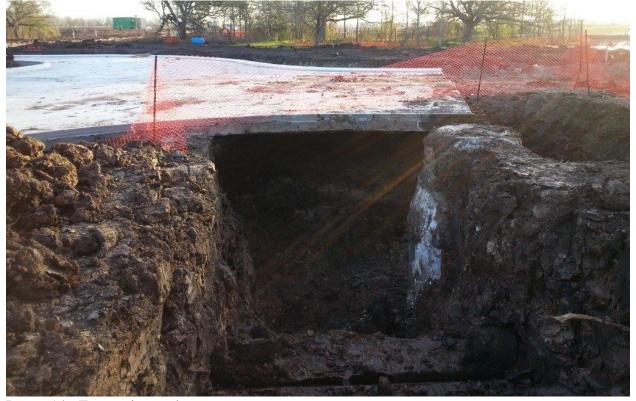
Image 14 - Excavation under or near pavement

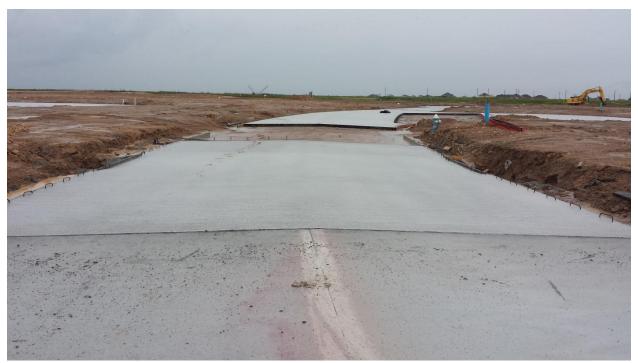
Image 15 - Not saw cutting within specified time (photo shows 4 day old concrete with no sawcuts)

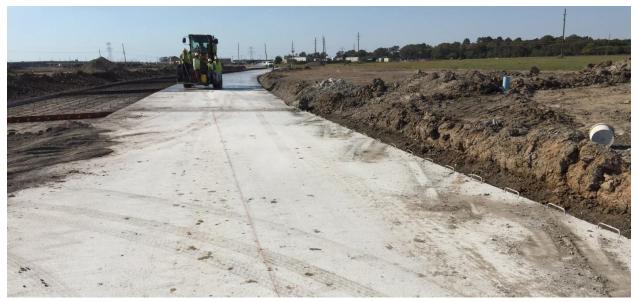
Image 16 - Equipment operating on pavement with inadequate cure time.

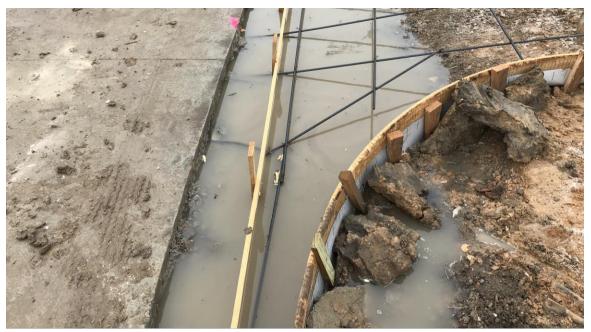
Image 17 - Driveway cut with water sitting weakens the subgrade
